A Shoreline Assessment of Pickkerel Lake

Completed by Northeast Glacial Lakes Watershed
Improvement and Protection Project

Commissioned and printed by the
Pickkerel Lake Conservancy
August 2018

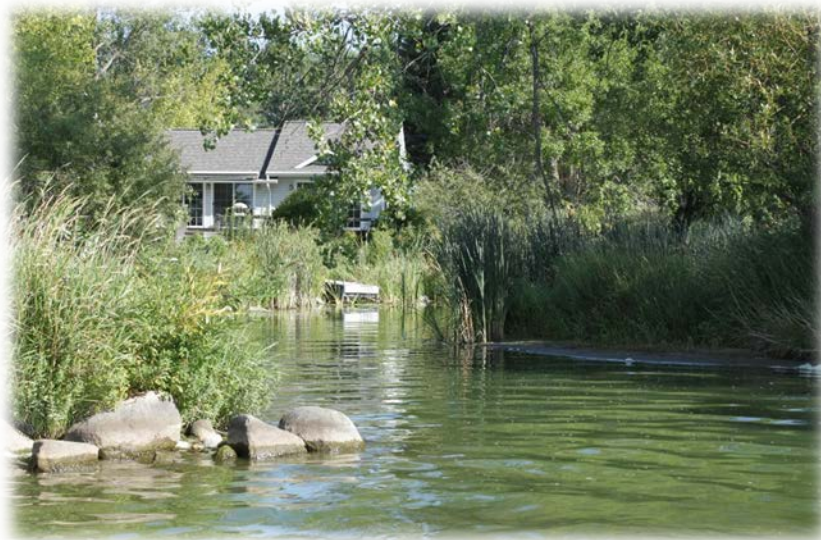
Figure 3.

On the left is a typical rocky shoreline with shrubs and grass, on the right is a depositional beach protected by emergent aquatic plants, grasses, and sedges.

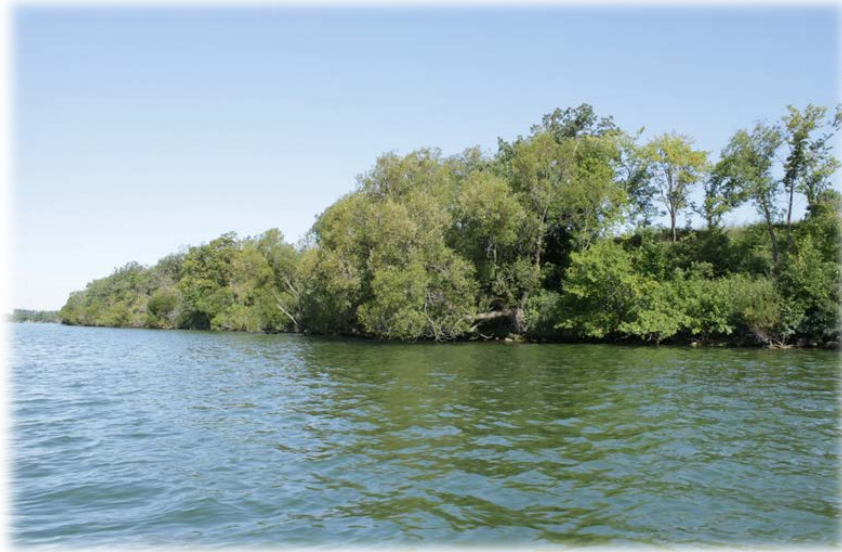
- ***Undisturbed Shoreline and Upland (shown below)***

No alterations to shoreline observed, native vegetation in place along shoreline, upland habitat (forest or grassland) intact or planted wildlife habitat in place (pine/cedar plantings), no structural development present.

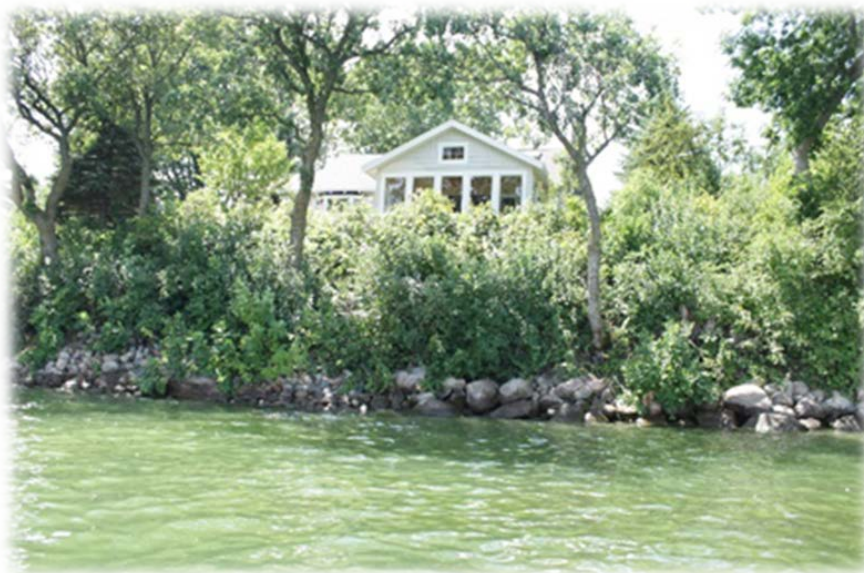
- ***Undisturbed Shoreline – Disturbed Upland (shown below)***

No alterations to shoreline observed, native vegetation in place along shoreline, some trimming of trees and shrubs observed, some shoreline structures present (docks, boat houses), upland habitat removed and replaced with manicured lawn and structures.

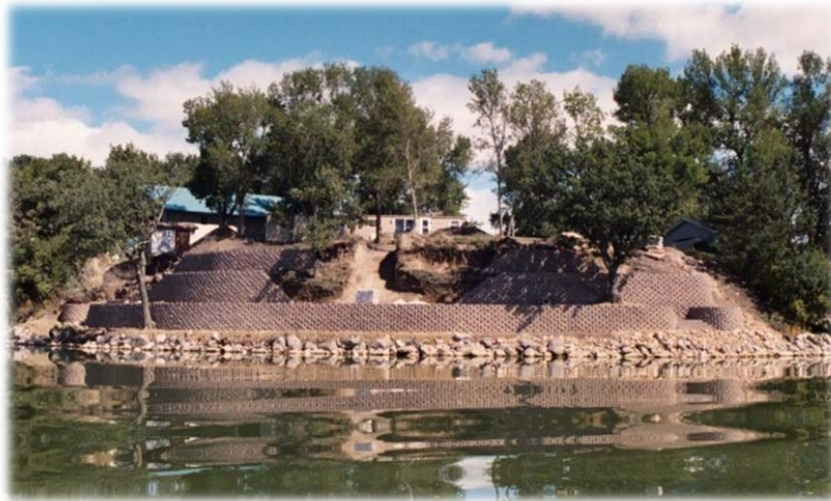
- ***Disturbed Shoreline and Upland (shown below)***

Shoreline altered by removal of natural shoreline structure and native vegetation, native trees and shrubs removed from water's edge to upland, upland replaced with manicured lawn and structures. Disturbed shorelines replaced with rock rip-rap, concrete seawalls, or hard landscaping features.

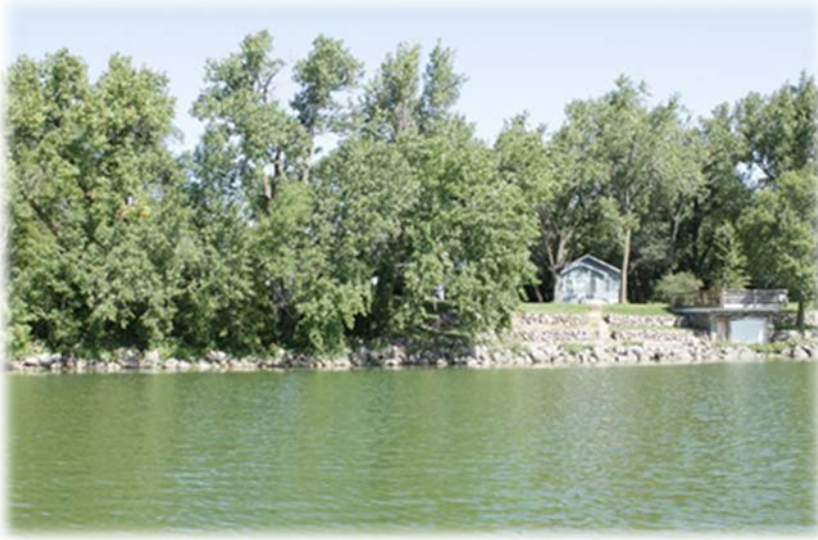
Figure 4. Undisturbed shoreline on the left with disturbed shoreline on the right.

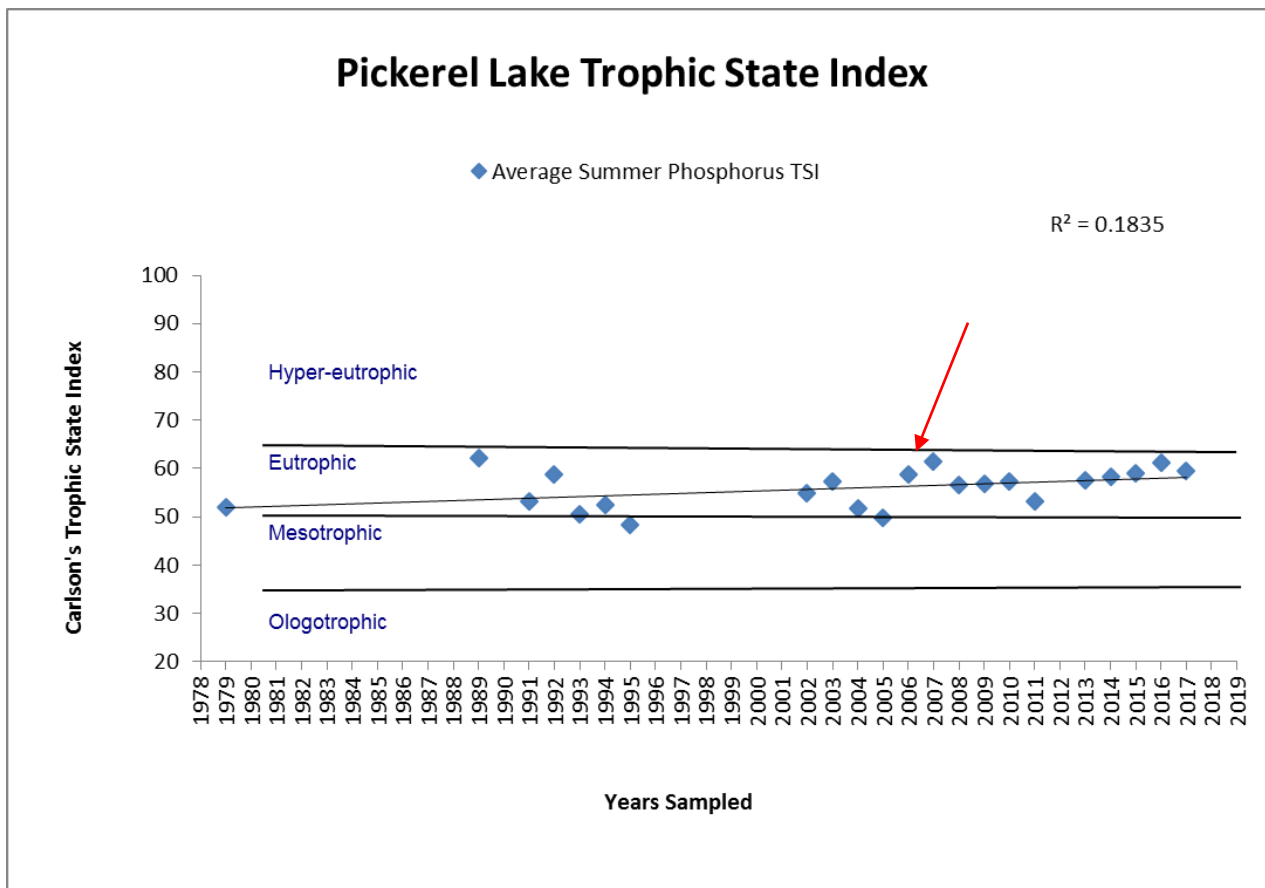
Figure 6. Pickerel Lake Trophic State – Phosphorus

Water quality testing of Pickerel Lake has shown how shoreline development effects water quality. During 2006 and 2007, several areas of the lake were disturbed for completed and proposed developments, including conversion of the YMCA Camp Wisagoma to private lake lots, conversion of a lakeshore wetland to an open bay for development of lake lots in Block's Bay, and earthwork completed on Tribal Trust Land (Figure 7) on the lake's northeast shores for a proposed development that was never completed. Based on water quality test results during these two years, Pickerel Lake's Trophic Status based on Total Phosphorus moved from a more Mesotrophic TSI in 2004 and 2005 to a very high Eutrophic TSI in 2007 (Figure 6). While the sharp increase in TSI did not continue into 2008, the graph shows a steady increase in eutrophication is occurring and the cumulative effects of non-point source pollution from external and internal loadings is ongoing in Pickerel Lake.

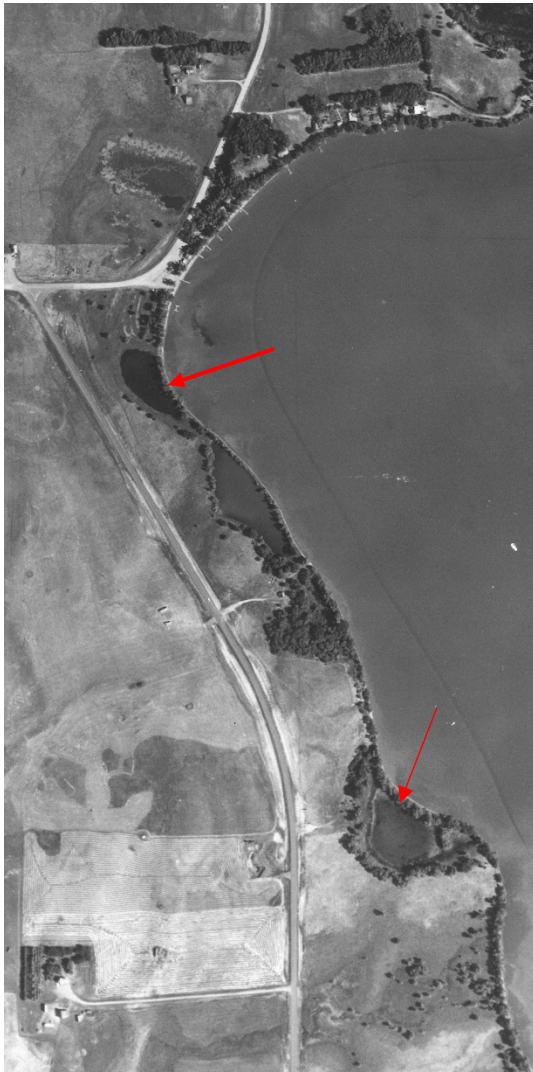
Figure 8. 1958 Aerial Imagery

It is harder to quantify historically how shoreline development has affected Pickerel Lake. Looking at aerial imagery from 1938, 1958, 1971, 1979 and 1984, it appears most of the shoreline development took place between 1958 and 1971. Hand measurements from several sets of aerial maps

show that in 1938 approximately 7,300 lineal feet (1.4 miles) of Pickerel Lake's shoreline was developed, mainly in three areas: Hyde Park, Ramona Beach, and the largest area at the time, South End. By 1958, four more areas were developed: Bass Beach (later called Beal's Addition), Jewett's Addition, North Pickerel, and Tahahe Point, increasing developed shoreline to approximately 12,900 lineal feet (2.5 miles). Four more areas of developed shoreline were added by 1971 including Chekapa Bay, Dulynn Road, Duncan's Addition, and Pickerel Lake Outlet, increasing developed shoreline to approximately 20,500 lineal feet (4 miles). By 1979 two more areas were developed, Bullhead Bay and Pickerel Lake State Recreation Area, increasing developed shoreline to approximately 24,130 lineal feet (4.6 miles). Turtle Bay was added to the shoreline by 1984 increasing shoreline developments to approximately 25,120 lineal feet (4.8 miles). In 2007, Shepherd's Bay and the former YMCA camp were developed for lake homes.

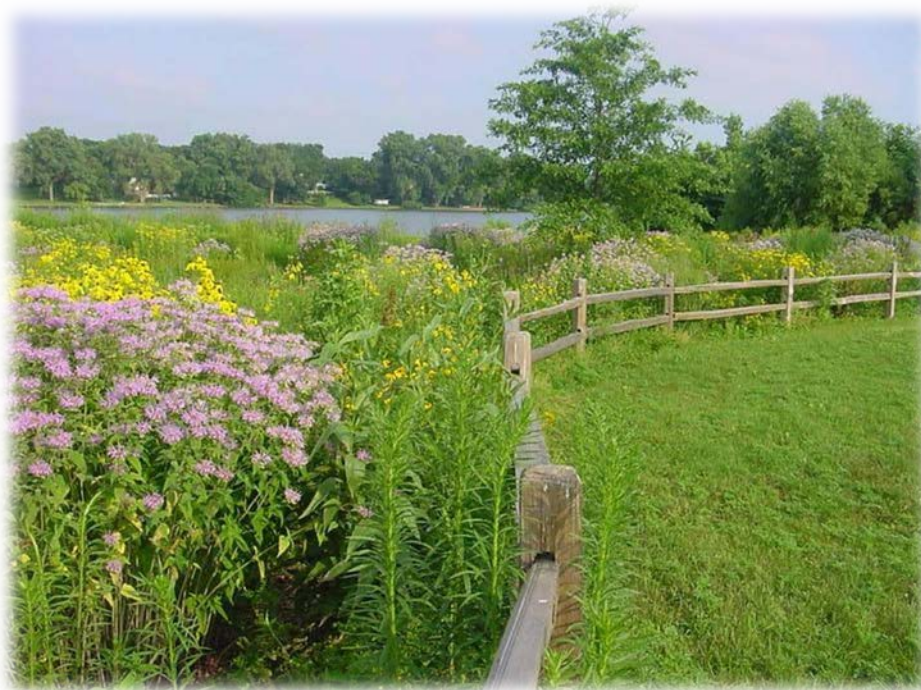
Figure 12. Completed Vegetative Buffer.

Most resource agencies recommend a buffer width of 25 to 100 feet in width from the water's edge to a manicured lawn or other disturbance as shown in Figure 12. The length of the buffer should cover a minimum 50% of the shoreline with 75% being optimal. Very few existing properties on Pickerel Lake would be able to implement any buffer greater than 25 feet in width due to the proximity of most lake homes and cabins to the shoreline. However, even buffers as wide as 10 feet would have benefits to the lake and wildlife.

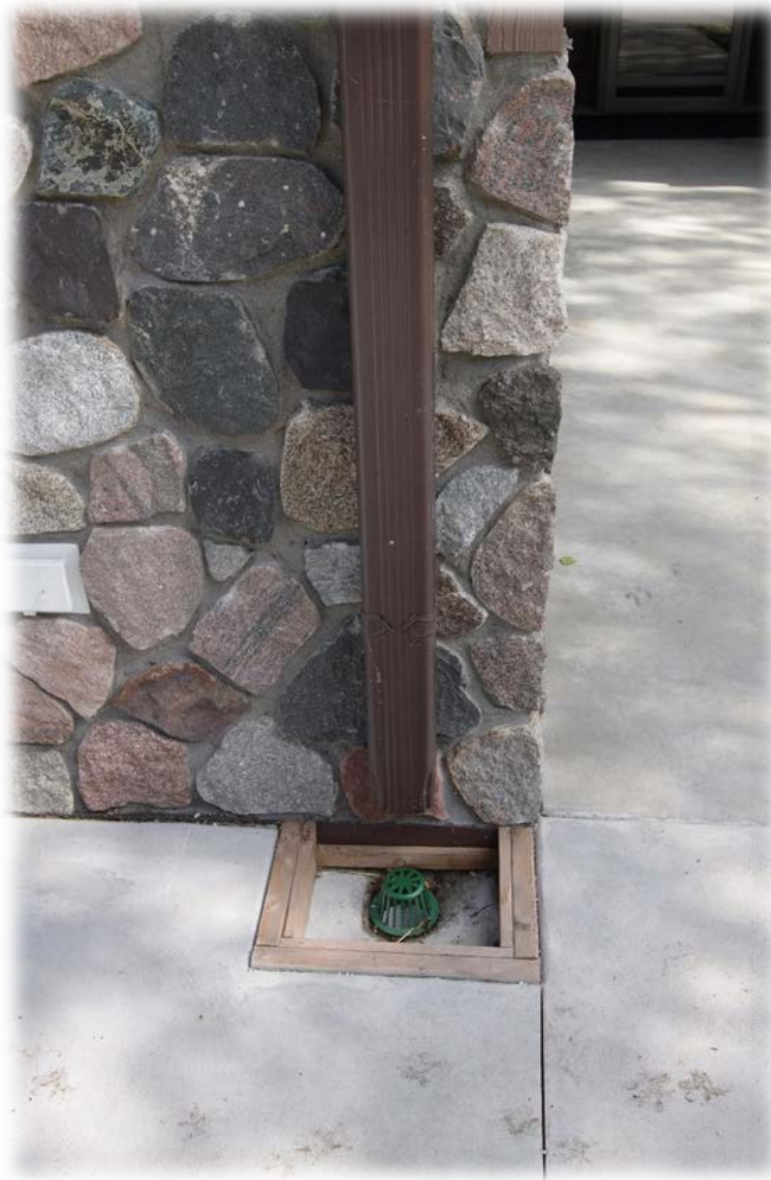
Figure 13. Sub-Surface Drains System

Surface runoff from buildings can cause serious erosion in the riparian zone where steep slopes and highly erodible soils combine. In these areas, runoff from lake homes and other hard surfaces should be contained in rain barrels or rain gardens or diverted away from the lake shore by placement of rain gutters and downspouts. Downspouts should not drain onto paved surfaces. Figure 13 below shows a sub-surface drain system used to collect runoff from a lake home and carry it away from the lake.

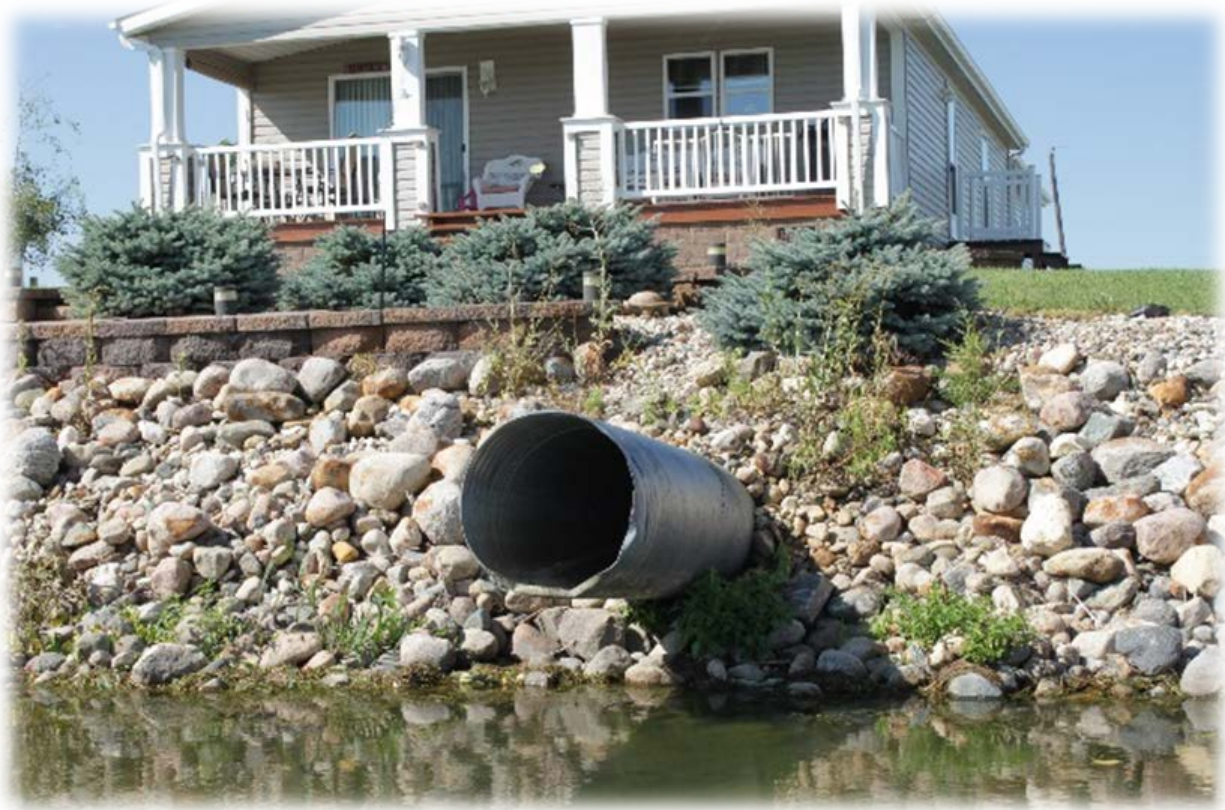
Five culverts were observed above the water line draining into Pickerel Lake including the one shown in Figure 14 located in Block's Bay. There may be more that enter below the water line that we did not observe. These culverts appear to be in areas of natural drainage, except for one that probably controls the elevation of a wetland to protect a county road. These culverts carry surface water and likely organic material and sediment to the lake during snowmelt and rainfall events. Where culverts drain into the lake, personnel should investigate the immediate upstream watersheds of these drainages to determine watershed size (acres), land use and possible water quality threats. At a minimum, sediment basins and trash screens at the upstream end of these culverts should be installed if possible to prevent organic material and sediment from reaching the lake. A Water Control and Sediment Basin should be considered on the lake's south end. I would suggest the Conservancy hire a civil engineer to undertake a feasibility study of these suggestions. The Pickerel Lake Conservancy will have to work with county and township personnel to design, implement, and maintain these structures if feasible.

Figure 14. Drainage Culvert located in Block's Bay
